# Evaluation of corrosion inhibition capability of graphene modified epoxy coatings on reinforcing bars in concrete

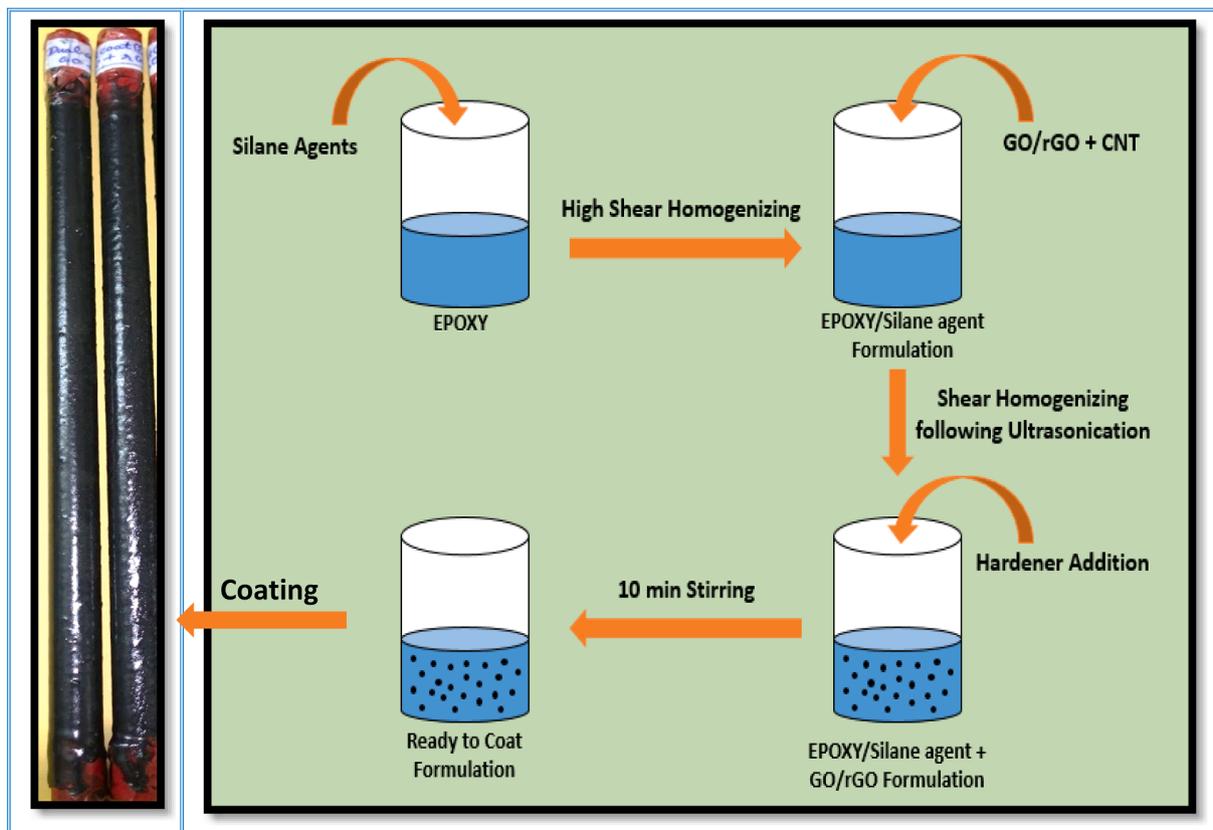
Fig. 1. Schematic diagram of synthesis of rGO/GO modified epoxy coating.

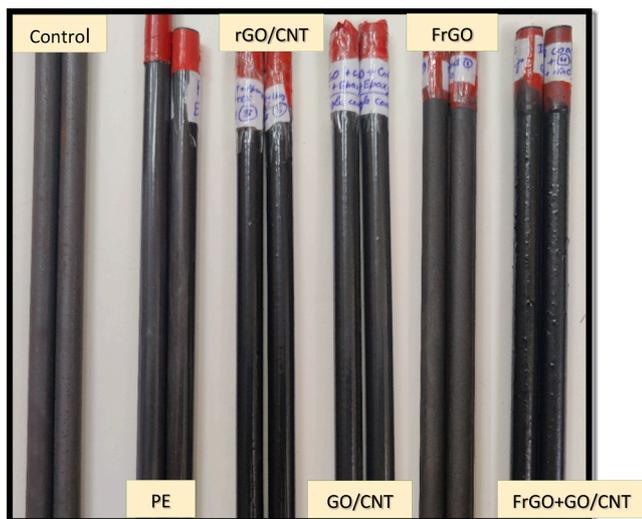
Fig. 2. Control bar and prepared coated bars.

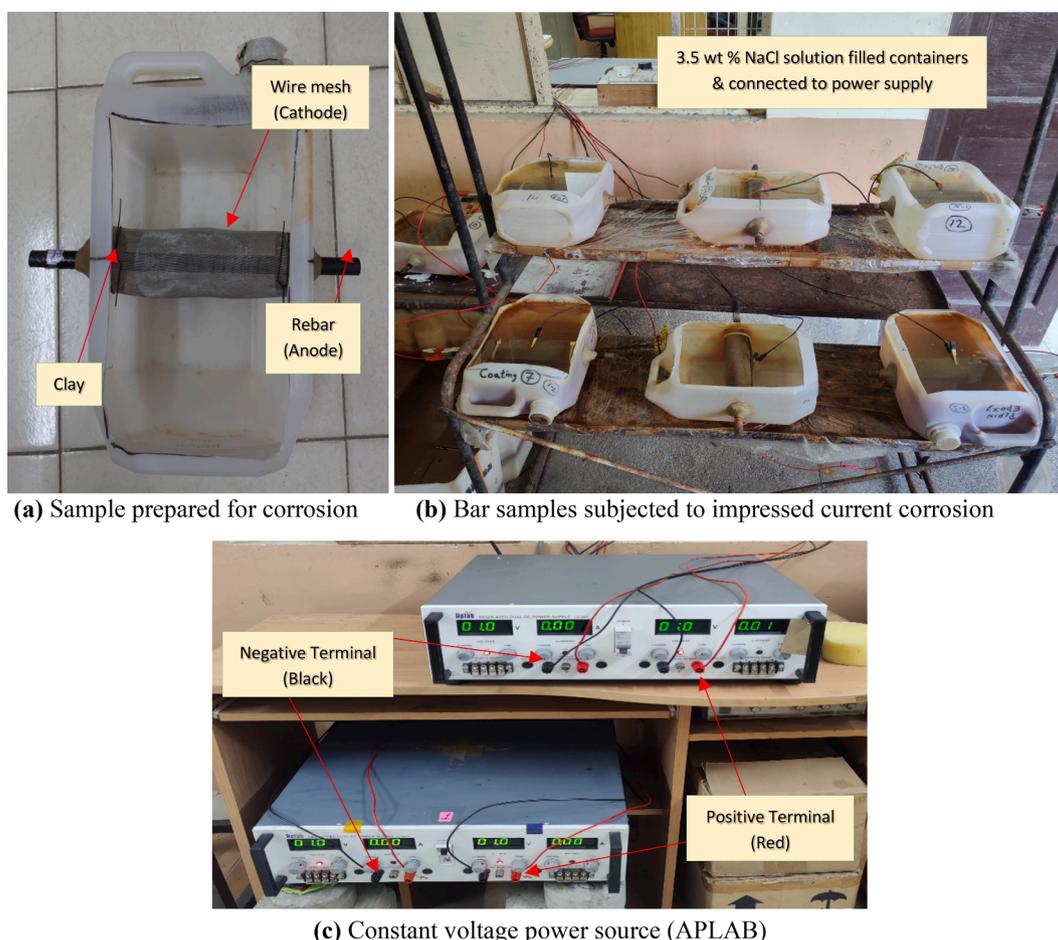
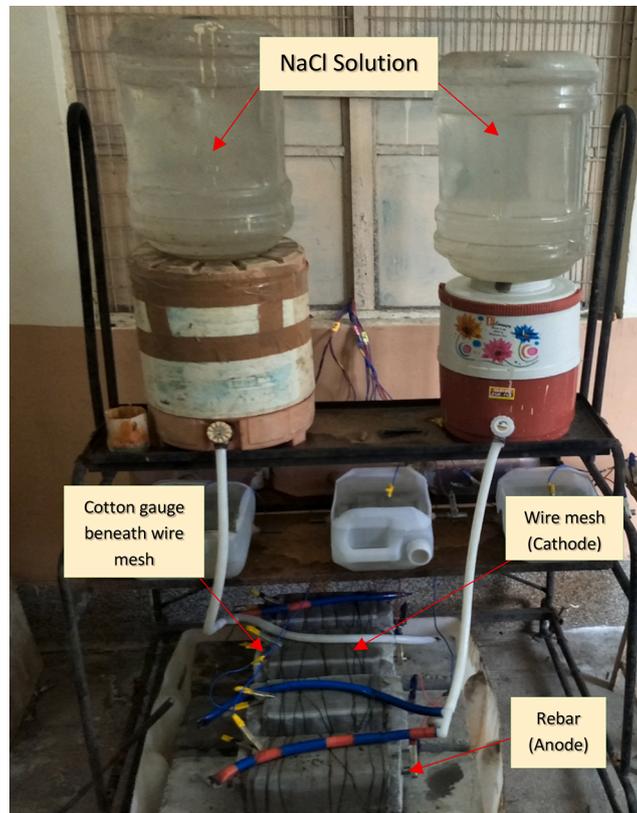
Fig. 3. Set-up for corrosion testing.

(d) Concrete samples subjected to accelerated corrosion

All the steel bar samples, plain as well as embedded in concrete, were subjected to accelerated impressed current corrosion at constant voltage of 1 V and 15 V, respectively (Fig. 3). High voltage is used for impressing corrosion in coated bars in concrete to accelerate corrosion in a lesser duration of time to arrive at useful strategies for corrosion inhibition and protection [35,81-86,91-93]. A brief description of the testing follows. For plain rebar samples, a container of width less than 1ft. with holes at the sides to place the rebar was prepared. The rebar was placed in the middle of the container with projection of 20–25 mm on both sides, and its ends were sealed with clay to minimize corrosion at the junction. A stainless steel wire mesh was wrapped around rebars to act as a cathode in the corrosion cycle (Fig. 3a) and was connected to the negative terminal of the constant voltage power supply (APLAB Make, Rating of 0-5A, 0-64 V). The rebar served as anode and was connected to positive terminal of the power supply. The container was then filled with the 3.5% NaCl solution. Plain rebar samples were corroded at constant voltage of 1 V throughout the testing period. Corrosion current was noted after every 6 h of interval to quantify corrosion as non-destructive evaluation for all the rebar samples without concrete. Three samples of each rebar coating type were tested to ensure uniformity and repeatability of results.

Similarly, for rebar samples embedded in concrete, the concrete specimens were wrapped with cotton gauge for maintaining uniform moisture by brine solution drip and a stainless steel wire mesh was wrapped on top of it (Fig. 3d). The bars acting as anode and stainless steel wire mesh as cathode were connected to the power supply and

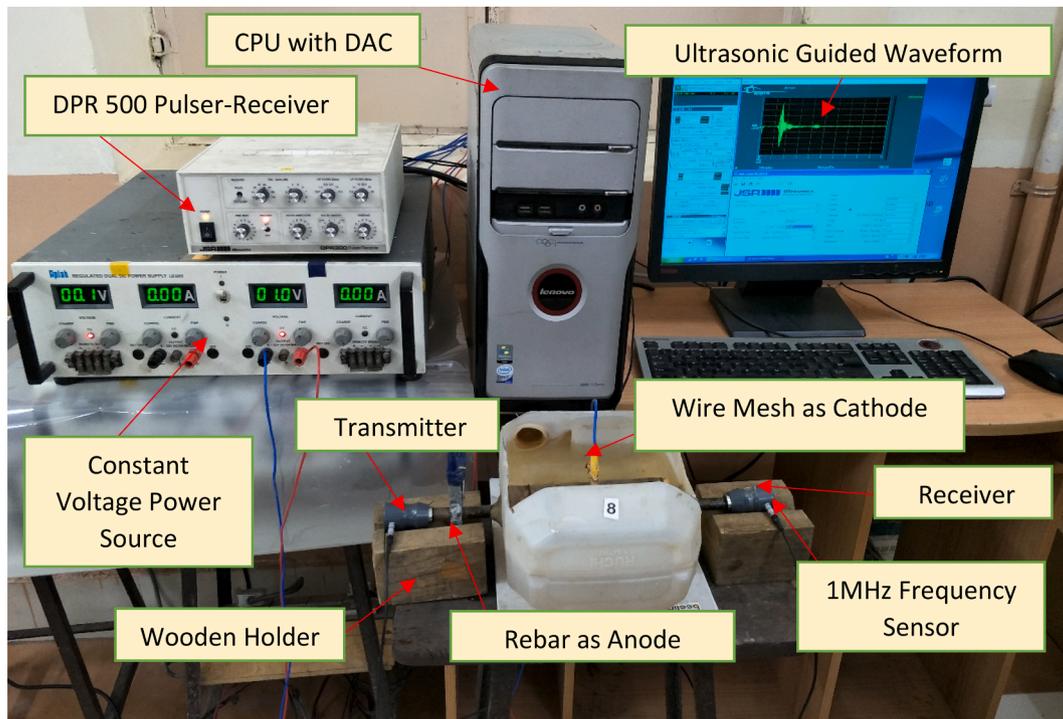
Fig. 4. Setup for ultrasonic guided wave monitoring.

The effectiveness of corrosion inhibition of different types of coatings mentioned in Table 1 was also studied using non-destructive technique of ultrasonic guided waves propagated through rebars. The process of monitoring was similar to that suggested by Sharma et al. [35,91]. The conventional ultrasonic guided wave mode of L (0, 7) was used for excitation at 1 MHz high frequency guided wave, which was reported to be effective in picking up pitting effect of corrosion in 12 mm rebars [35,82-85,91-93]. A conventional UT system consisting of pulser-receiver device (DPR 500, Karl Deutsch Make), 12 mm diameter cylindrical transducers (Karl Deutsch Make) with frequency of 1 MHz and Data Acquisition Card (DAC) of Aquiris Make was used for ultrasonic testing. The ultrasonic testing was done in through-transmission mode in which the transmitter as well as receiver probes were kept along the longitudinal axis of the rebars (Fig. 4).

The transmitter and receiver transducers were kept in place using a holder assembly to maintain constant pressure at both ends of the rebar throughout the testing process. Briefly, the UT system excites the transmitter which sends guided wave signals in the rebar, with the receiver receiving the transmitted waves at the other end. The transmitted signals through the corroding rebars are then analyzed to assess the level of deterioration. It is marked by fall in transmitted signal strength due to the pitting and area reduction in the rebars undergoing accelerated impressed current corrosion leading to signal attenuation. Multiple reflections and guided wave mode scattering due to pits in rebars cause drop in signal strength. Fall in signal vis-à-vis signal in the initial healthy bar indicates deterioration in the rebars due to corrosion.

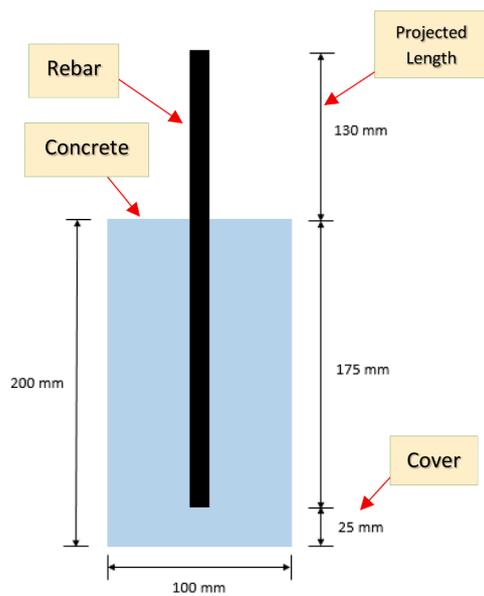
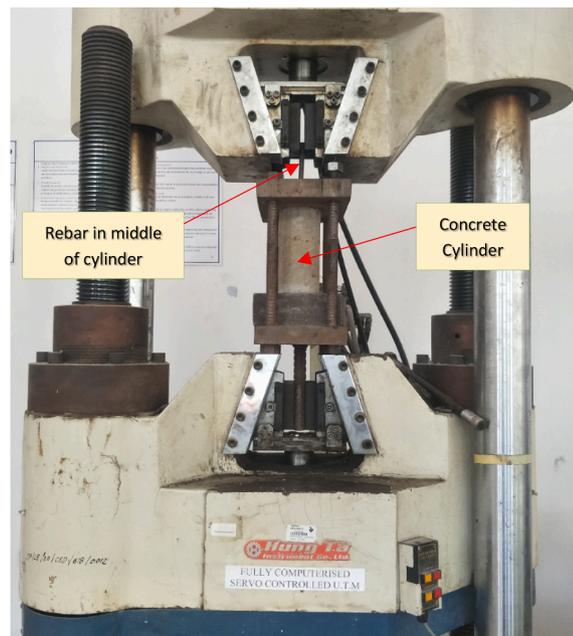
(a) Schematic of specimen

(b) Pullout testing in UTM

Fig. 5. Pullout test specimen and Set-Up.

Another set of coated rebars were cast in concrete and subjected to pullout test to evaluate the effect of epoxy-based coatings on the bond strength between concrete and the rebar. Any kind of coating on rebars in concrete should not compromise its bond strength with surrounding concrete. This is the basis of design of reinforced concrete sections and hence, it is very important to investigate the bond effect of coatings on rebars. All five differently coated rebars coatings and control rebars were cast in concrete cylinder of 100 mm diameter and 200 mm length. The concrete design mix used for the preparation of cylinders was similar to that mentioned in Section 2.1. Cylinder specimens having 12 mm mild steel rebars in the middle of the cross-section were placed at a cover of 25 mm from the bottom and projected at the other end by 130 mm out of the cylinder (Fig. 5a). The casted cylinders were cured for 28 days at room temperature and then subjected to pull-out strength testing using Universal Testing Machine (Hung Ta Make, Capacity 1000 KN) at

a loading rate of 0.5 kN/second till failure (Fig. 5b). Three samples of each type of the coated rebars were tested to calculate the average pullout strength.

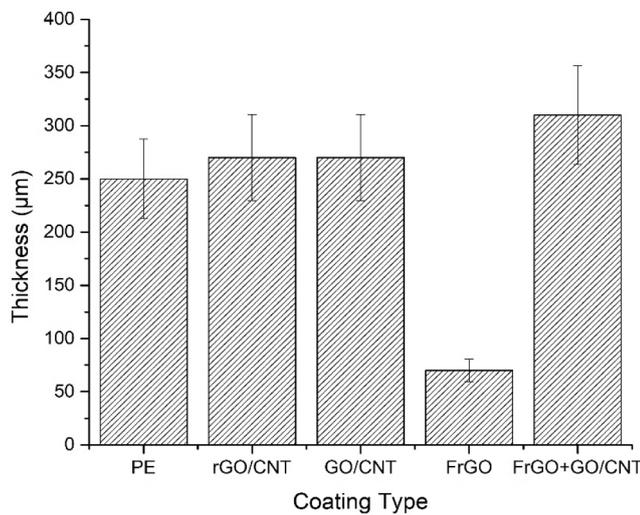
Fig. 6. Average thickness of different types of coatings.

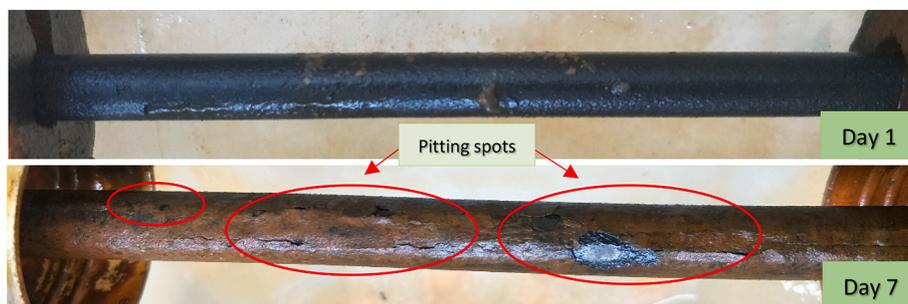
Fig. 7. Visual images of control (uncoated) rebars.

All the coated rebars were subjected to accelerated impressed current corrosion and their performance was assessed by visual observations and through variation in corrosion current and ultrasonic guided wave measurements. Samples were periodically removed from the power supply and observed visually to examine the effect of accelerated corrosion. Accelerated corrosion was stopped when the guided wave signal vanished completely. In **control rebars** with no coating, corrosion initiated within the first hour of the exposure and the bar experienced uniform corrosion throughout the length. After 7 days of accelerated corrosion exposure, the rebars suffered pitting at different locations and within 8–9 days of exposure, ultrasonic guided wave signals completely vanished and accelerated corrosion testing was stopped (Fig. 7).

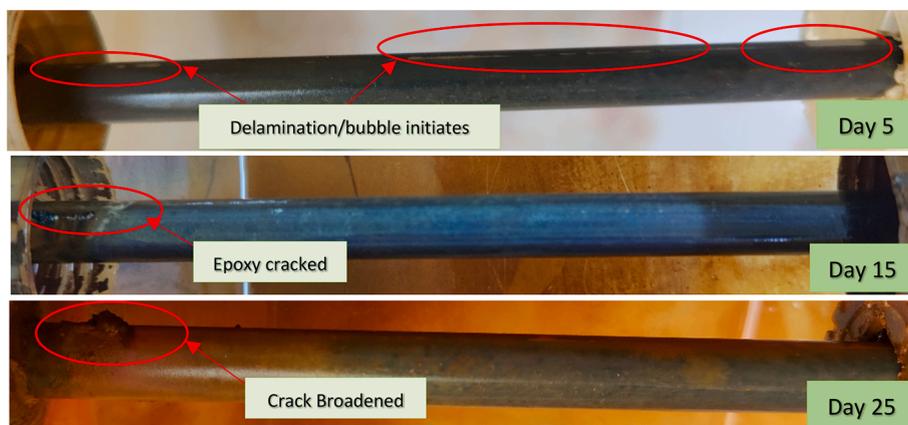
Fig. 8. Visual images of PE coated rebars.

For the **PE coated rebars**, within 5–10 days of accelerated corrosion, delamination of the epoxy coatings from rebars was observed by bubble formation at different spots beneath the epoxy coatings (Fig. 8). It indicates penetration of aggressive chloride ions into the epoxy matrix by breakdown of passive layer indicating initiation of corrosion. After 15

days, it was observed that at one typical location of a PE bar, epoxy layer cracked leading to further ingress of aggressive ions and deterioration. After 25 days, this crack broadened and accumulation of corrosion product was noticed near it, indicating localized pitting of the rebar at this spot. With increasing corrosion exposure, widespread cracking was observed accompanied by widespread pitting, which led to drop in ultrasonic guided wave signal, with the signal vanishing completely in 44 days as against 8–9 days in the uncoated rebar. Similar observations were made in other similar PE coated rebar samples.

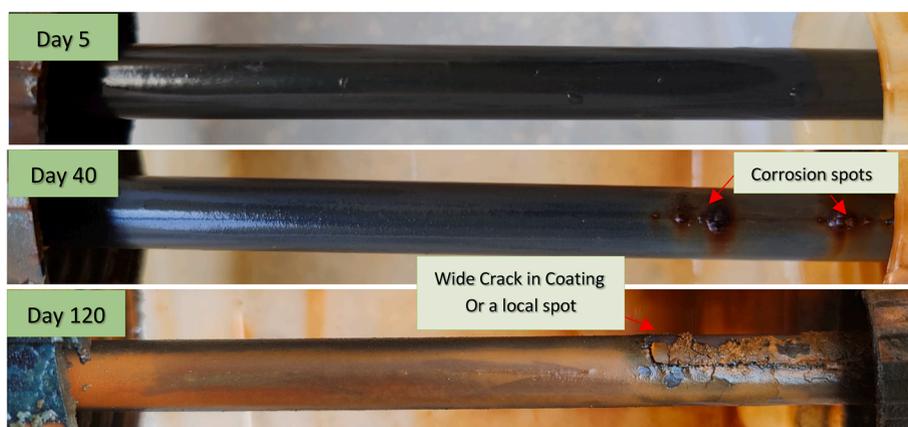
Fig. 9. Visual images of rGO/CNT coated rebar.

The *rGO/CNT coated rebars* held off corrosion for significant duration as compared to the PE coatings; no delamination or bubble formation was observed for 30 days (Fig. 9), possibly due to the hydrophobicity and tortuous path provided by the rGO nano particles in the epoxy matrix. The existence of CNTs toughens the graphene structure and improves the mechanical strength of epoxy nanocomposite [68,76,77]. After 30 days, initiation of corrosion was observed by breakdown of the passive layer, and within 40 days corrosion spots or bubbles were clearly visible, indicating accumulation of the rust product. The corrosion spots lead to formation of corrosion crack in about 60 days. In 100 days, the localized corrosion pit widened due to continuous pitting at that location. Spot widened but it is important to note that pitting was not widespread at many locations as in the control or PE coated bars, but once it initiated at a point, it could not be arrested. This was confirmed by a continuous drop in the ultrasonic guided wave voltage amplitude, which vanished in 125 days (average for all samples). Compared to 8–9 days for the control bar and 44 days for the pure epoxy coated bar, rGO/CNT coated bars perform significantly better in preventing corrosion.

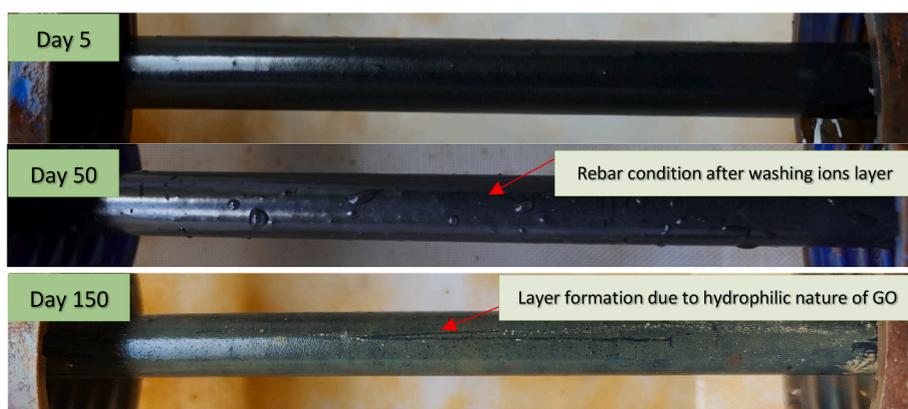
Fig. 10. Visual images of GO/CNT coated rebars.

*coated rebars* perform even better than the rGO/CNT coated rebars. There was no delamination or failure noticed in the form of local pits or cracks in the coating. After 60 days of accelerated corrosion, the rebar looked as healthy as on day 1 (Fig. 10). Even after 125 days of accelerated corrosion, the GO/CNT coated rebar showed no visible sign of deterioration in the form of pits or failure of coating or cracking at any point. This observation was consistent in two samples out of three. Only 1 sample showed some reddish brown stain at a localized point but no other visible increase in corrosion current or drop in guided wave signals was observed in this rebar. Till 150 days of accelerated corrosion of GO/CNT coated rebars, no change in non-destructive testing parameters of corrosion current as well as ultrasonic guided wave signals was observed in all the three samples.

A significant observation during testing is the presence of salt deposits on GO coated rebars. This can be explained by the hydrophilic nature of GO which attracts saltwater but the epoxy admixed with GO and CNT forms a dense impermeable network or layer which does not allow the entry of these chloride ions into the coating; they accumulate on the rebar with no penetration inside. The salt deposits are easily rubbed off by hand and the GO/CNT coated bars appear as originally coated shiny bars. The coating remained intact even after 150 days of accelerated corrosion.

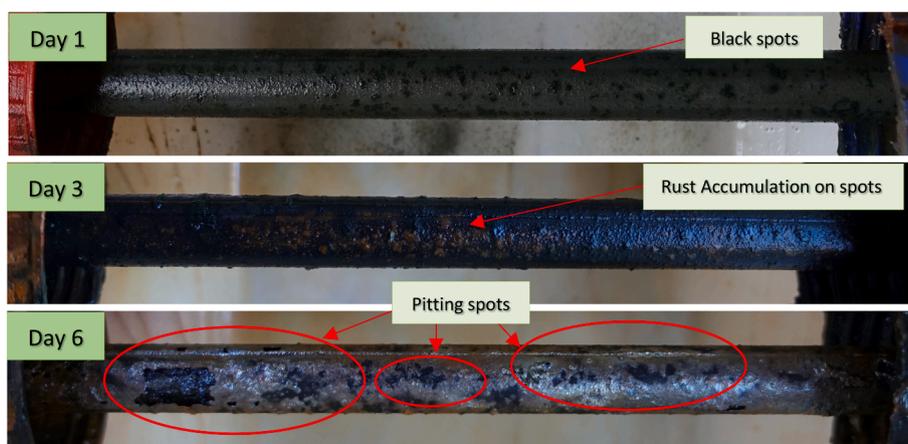
Fig. 11. Visual images of FrGO coated rebars.

In functionalized coated rebars without epoxy (*FrGO coated rebars*), corrosion initiated in similar pattern as in the uncoated rebars and performed worse than rGO/CNT coated rebars since there was no epoxy present in the coating that could make it more vulnerable to the penetration of aggressive ions. Within 2–3 h of exposure, corrosion was initiated and after one day of corrosion, black spots were noticed on the rebars. Accumulation of the rust product was observed in 3 days, indicating pitting or progression of corrosion (Fig. 11). Within 7 days of accelerated corrosion, the rebar was badly corroded and the corrosion pits were observed at various locations. The guided wave signal vanished in 7 days earlier than for even the uncoated rebars. Similar results were noticed for all the other similar samples indicating more aggressive

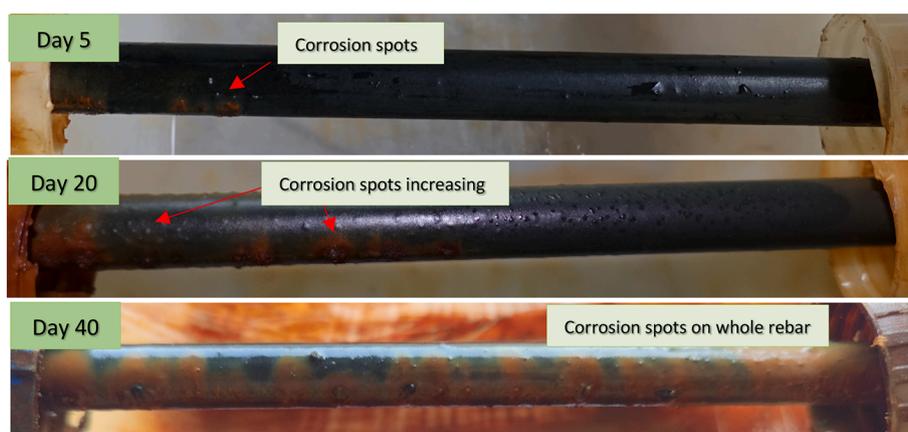
Fig. 12. Visual images of FrGO + GO coated rebars.

For the last coating considered on this study *FrGO + GO/CNT coated rebars*, distinctive features were observed as compared to the other epoxy coated rebars. During accelerated corrosion testing within first week of exposure, several corrosion spots were observed on the rebars in 5–7 days (in all three similar samples) (Fig. 12). This is probably due to the base layer of FrGO without epoxy which becomes the weak link and initiates corrosion. The aggressive chloride ions easily break this layer since there is no epoxy. Also, the conductive nature of rGO nano particles in this layer further accelerates the cathodic reaction which overpower its hydrophobic property. Within 40–50 days, the corrosion spots spread on the entire rebar with accumulation of the rust product, which finally leads to corrosion cracks during the later stages. The FrGO + GO/CNT sample could withstand accelerated corrosion for an average of 110 days (average of 3 samples). The presence of GO/CNT in the top layer with epoxy helps impermeable layer to hold corrosion exposure for significant duration.

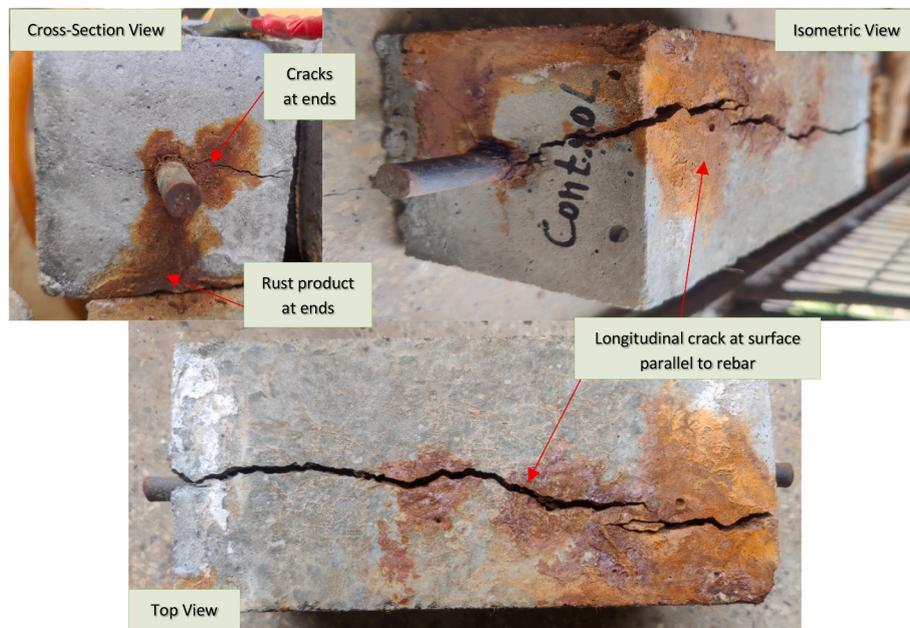
Fig. 13. Visual images of beam reinforced with uncoated bar undergoing accelerated corrosion.

During accelerated corrosion of the coated rebars embedded in concrete, visually three stages were observed. In the first stage, the rust product accumulates near the projected end of concrete section indicating initiation of corrosion. With the progression in corrosion, a crack appears on concrete cross-sectional ends. In the final stage, longitudinal cracks originate from sectional ends, which separate the concrete section into pieces. For the **control rebar** concrete specimens, the rust product was observed within 7–10 days of accelerated corrosion from the projected end of bar from concrete, and cracks appeared at the cross section ends within 15–16 days (Fig. 13). The side cracks progressed further in the form of surface longitudinal crack parallel to reinforcing bar (Fig. 13) in 25–29 days, which divided the concrete section into pieces. The control concrete specimen at that stage was in a highly dilapidated condition.

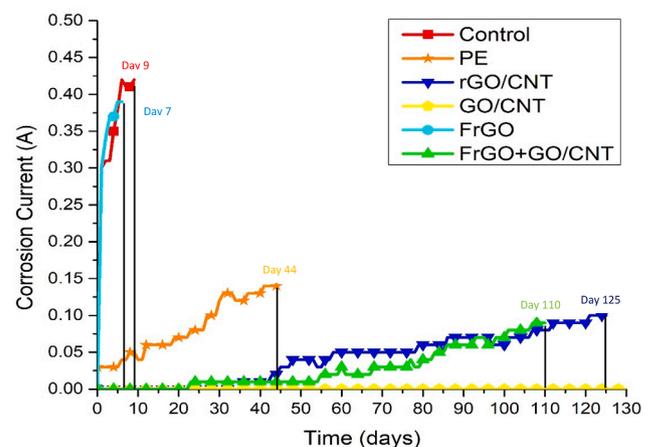
Fig. 14. Variation in corrosion current of rebars.

During accelerated corrosion testing of the rebars only, a constant voltage of 1 V was applied to the sample to accelerate the corrosion process. The corresponding variation in the corrosion current was monitored regularly and is represented in Fig. 14. Increase in corrosion current is an indication of corrosion initiation and progression. Further, sudden jump in corrosion current indicates that the coating gives way and aggressive ions penetrate and break the passive layer of oxides on the bars. In the samples with **control rebars**, this jump was observed within 2–3 h of accelerated corrosion exposure and corrosion current suddenly jumped from 0A to 0.3A. Further, the corrosion current kept on increasing at a constant rate and reached to a value of 0.42A in 9 days, at which time the ultrasonic guided wave signal completely vanished

In the **PE coated rebar**, small corrosion current was observed initially at the start of testing between 0.01A and 0.03A which remained constant till 6–7 days. After 6 days, sudden increment in corrosion current was observed indicating initiation of corrosion by breakdown of the passive layer as confirmed visually by the formation of bubbles indicating delamination of coating after 5 days. Pure epoxy was thus successful in delaying the initiation of corrosion up-to 6–7 days as against 2–3 h in control bars. Also, the rate of progression of corrosion in the PE coated rebars is very low as compared to control rebars. When the corrosion spots got converted into large cracks, a steep jump in the corrosion current between 29th –34th day was noticed. Overall, the PE coated rebar sustained corrosion up to 44 days with a corrosion current of 0.14A as compared to 9 days and 0.42A in the control bar, respectively.

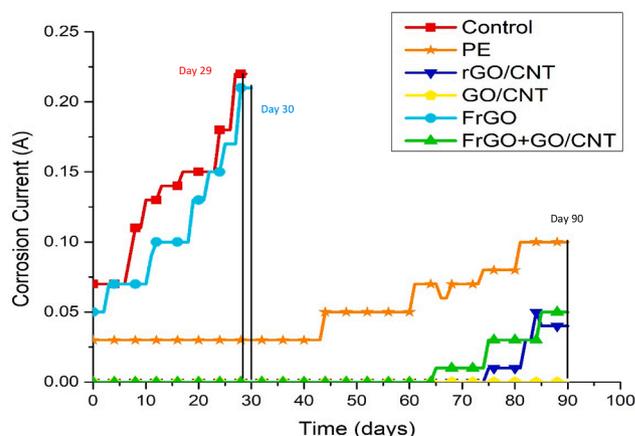
Fig. 15. Variation in corrosion current of coated rebars embedded in concrete.

The coated rebars cast in concrete were subjected to accelerated corrosion at constant voltage of 15 V for 90 days to investigate the efficacy of modification of the ECR with graphene modifiers in concrete. The corresponding variation in the corrosion current with increase in corrosion was recorded and is presented in Fig. 15. It is generally observed that the corrosion current trends in bars embedded in concrete are in exact coherence with bars tested without concrete in Section 3.3.1. In the **control rebar** concrete specimen, a first sudden jump in corrosion current was observed after 7–8 days indicating initiation of corrosion. The bar gave way in 29 days when a maximum current of 0.22A was observed and its ultrasonic signals had completely vanished. Similar trends and behavior were observed in the FrGO bars without epoxy (Fig. 15).

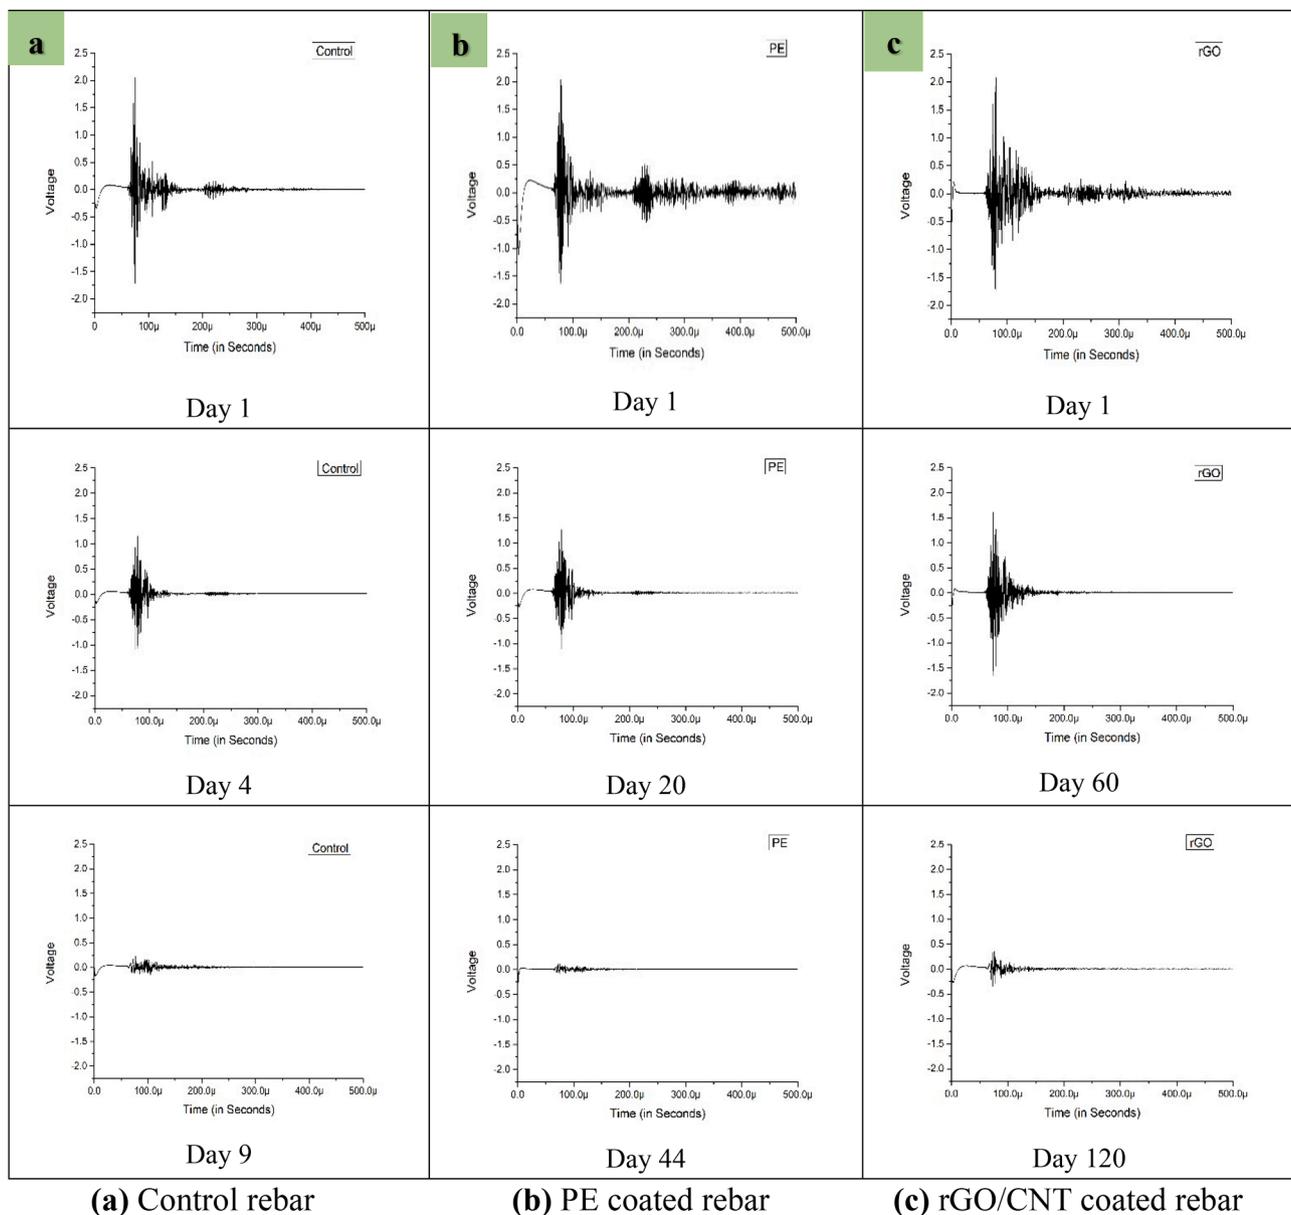
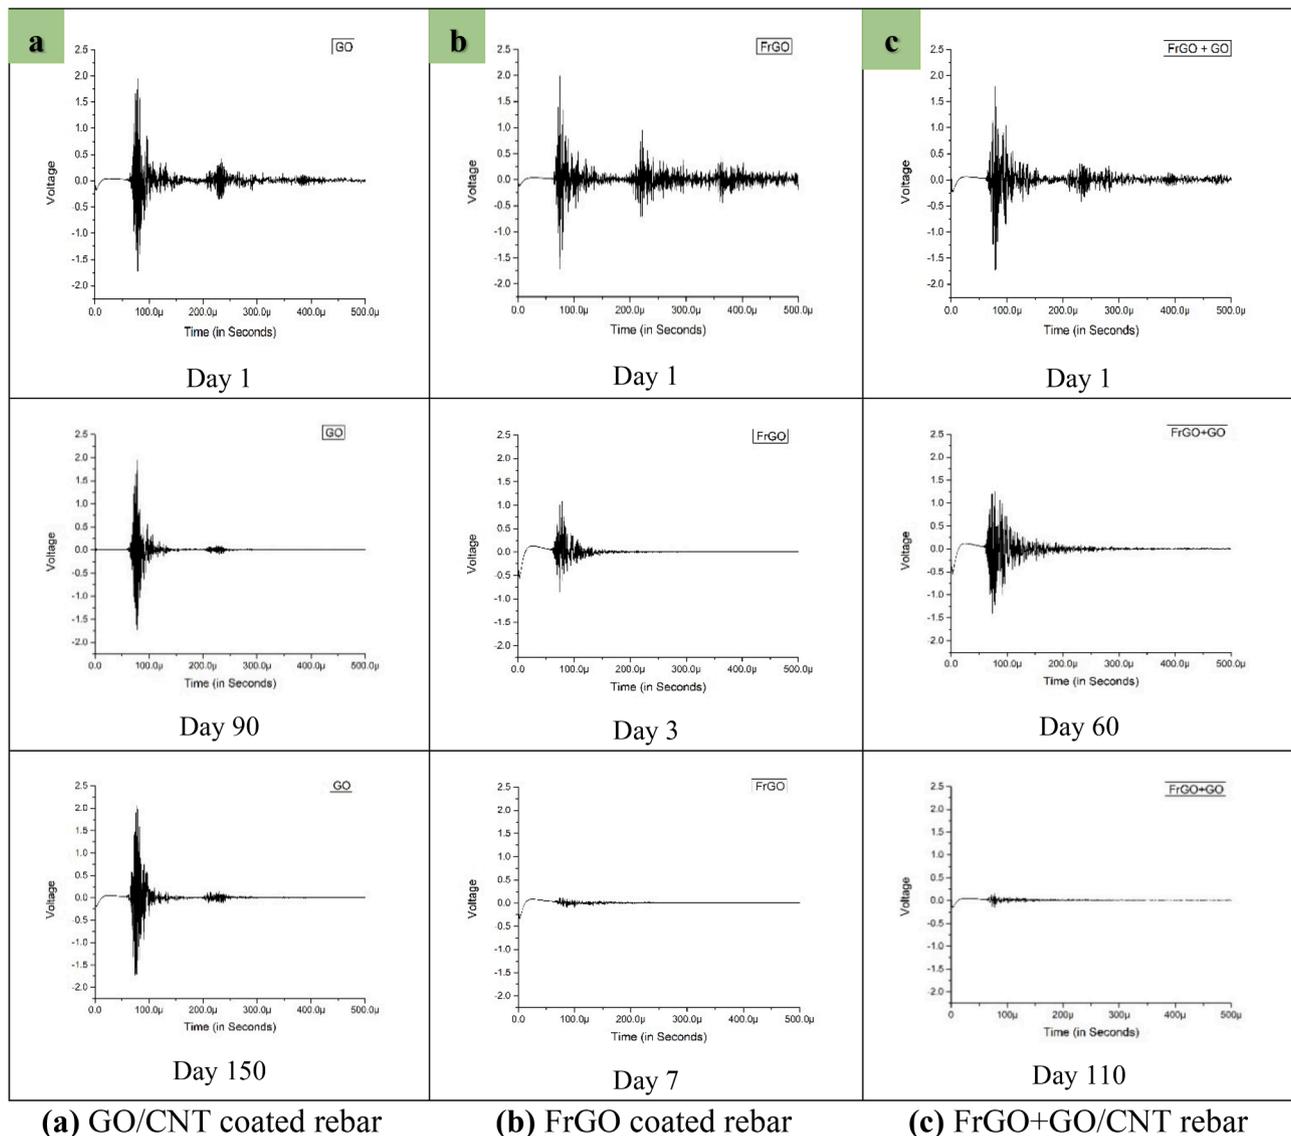
Fig. 16. Ultrasonic signatures at different phases of accelerated corrosion in coated rebars.

Fig. 17. Ultrasonic signatures at different phases of accelerated corrosion in coated rebars.

corrosion testing for the control rebar and differently coated rebars are shown in Fig. 16 and Fig. 17. From ultrasonic signatures, the peak-to-peak voltage of the received signals for the bars with increasing corrosion is plotted in Fig. 18 as a ratio of that for the healthy rebar. As the corrosion increases or coating gives way to aggressive media, the rebar start losing its material in the form of rust; pitting initiates and the guided wave signal strength starts decreasing since the guided wave travelling through the rebar experiences scattering and mode conversions as it interacts with the pits leading to drop in signals.

From the ultrasonic signatures shown in Figs. 16 and 17, it can be observed that initially all rebars have highest signal amplitude which depletes with increasing corrosion level. In *control rebars*, there is a consistent drop in the peak-to-peak voltage ratio right from Day 1 and finally the signal vanishes in 9 days (Figs. 18 and 16a). The *FrGO coated rebars*, without epoxy, behave in a similar way to control bars and ultrasonic signals completely vanish in 7 days pointing to the ineffectiveness of FrGO without epoxy in corrosion inhibition (Fig. 17b). On the other hand, in the *PE coated rebars*, the signal could sustain for 44 days (Fig. 16b) as against 9 days in the uncoated bar. Corrosion initiates after 8 days in the PE bar as indicated by the first drop in the peak-to-peak voltage ratio, which continuously falls and depletes completely (Fig. 18). It is important to mention that the rate of fall of the peak-to-

In the *GO/CNT coated rebars*, no drop in ultrasonic signal amplitude was observed even after 150 days (Fig. 17a and Fig. 18) of accelerated corrosion. These results are in complete coherence with the corrosion current measurements. The GO/CNT coated rebars were able to stop corrosion from occurring all together. No initiation was picked up either visually, or by an increase in corrosion current or by a drop in ultrasonic guided wave signals pointing towards the superior and better corrosion inhibition as against the rGO/CNT coated rebars.

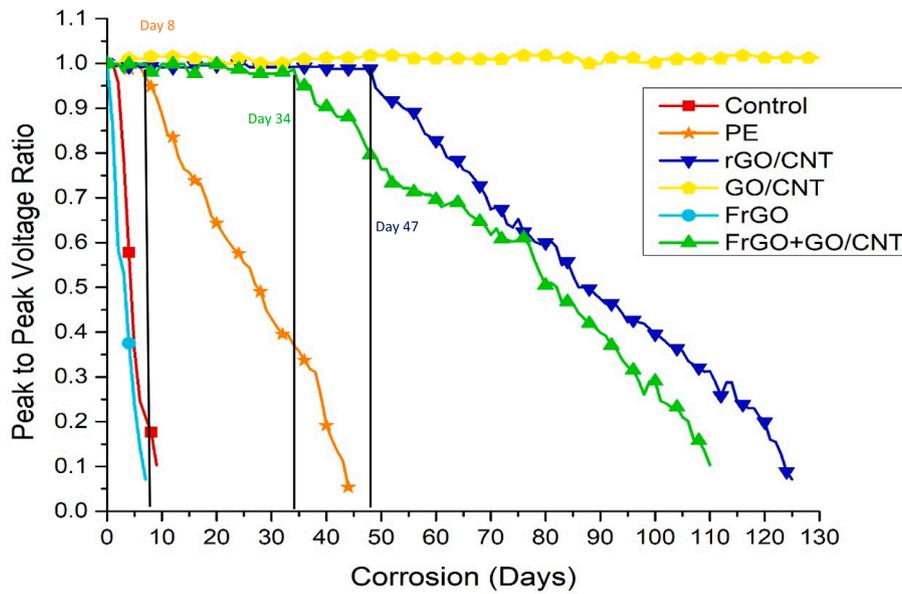
Fig. 18. Peak to peak voltage ratio of rebars only with increasing corrosion.

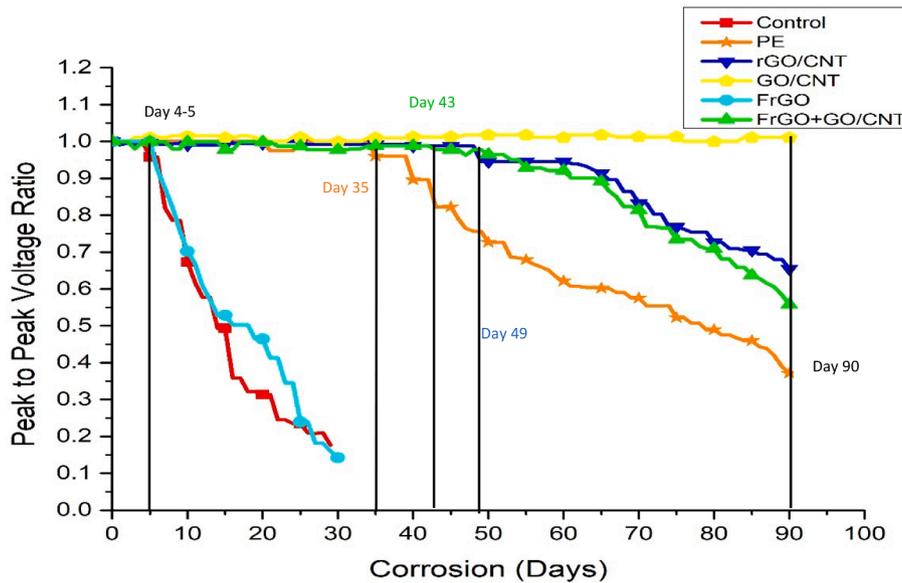
Fig. 19. Peak to peak voltage ratio of rebar embedded in concrete with increasing corrosion.

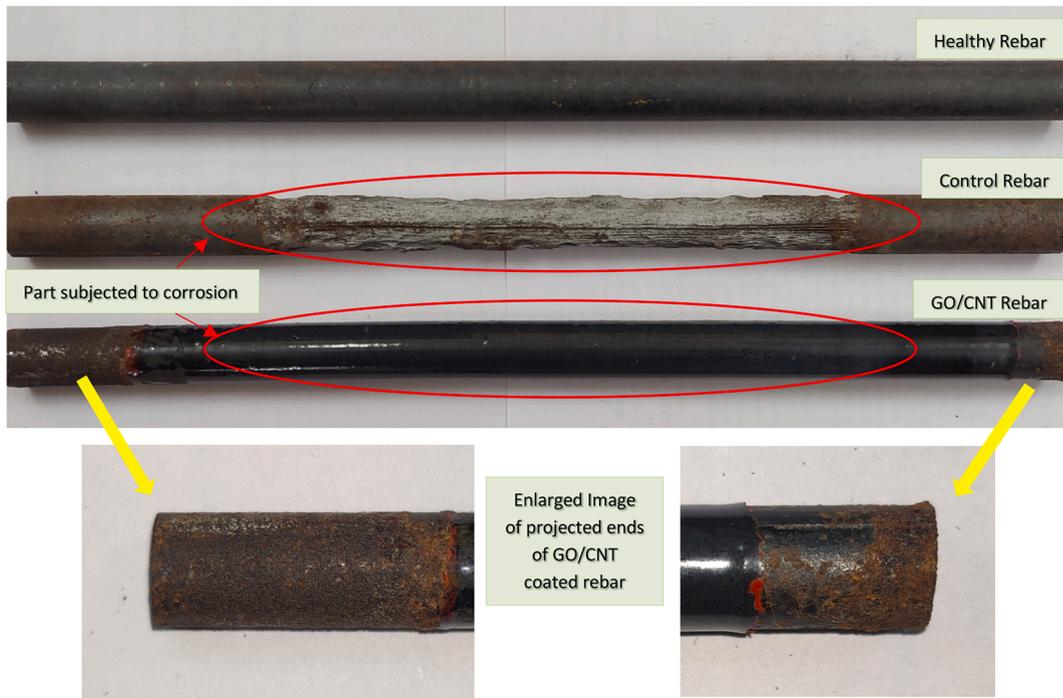
Fig. 20. Condition of healthy rebar, corroded control rebar and GO/CNT coated rebar.

Healthy rebar, control rebar and GO/CNT coated rebar cleaned after corrosion exposure are presented in Fig. 20. It can be observed that in control rebar reduction in diameter of rebar due to pitting of corrosion was almost uniform throughout the length with approximate residual diameter of 8–9 mm as compared to the original 12 mm diameter. In the

GO/CNT coated rebar, the coating was intact with no visual damage due to corrosion to the region subjected to accelerated corrosion. But the projected ends of this rebar which were uncoated and subjected to surrounding aggressive environment experienced minor degradation. From Fig. 21 it can be observed that, in the PE coated rebars, a deep pit was observed at one place with multiple pits throughout the extracted bar.

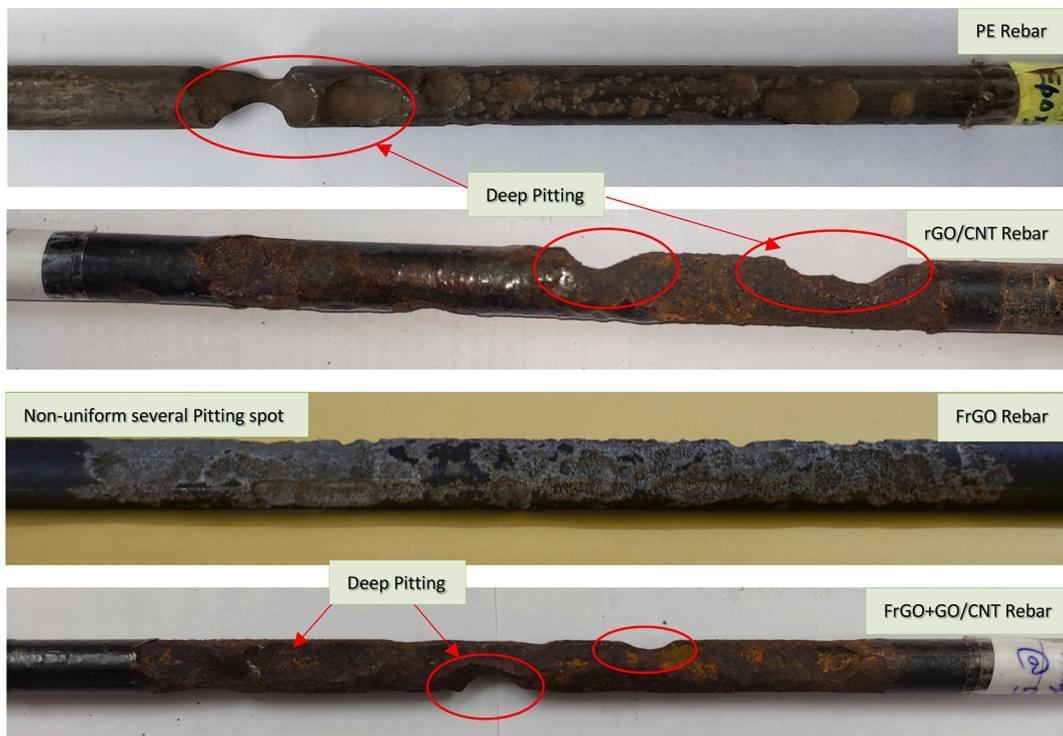
Fig. 21. Corroded rebars with different coatings.

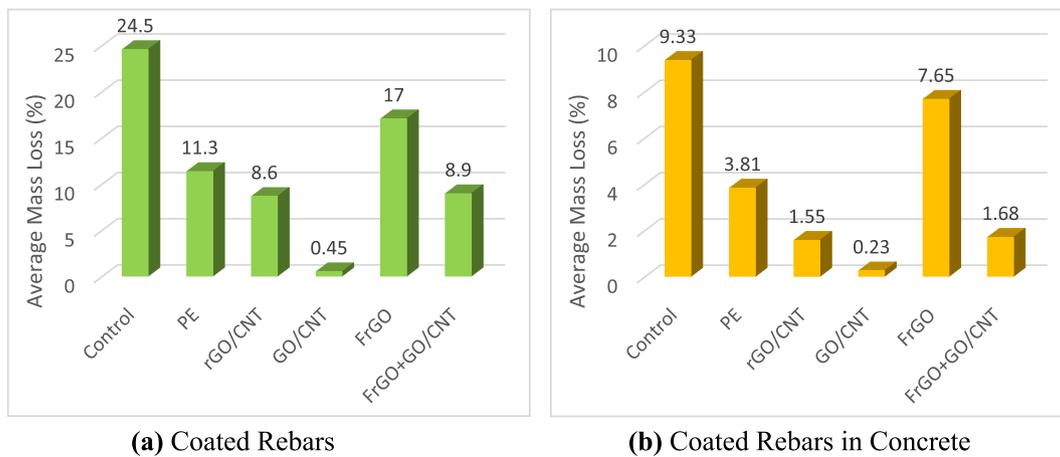
Fig. 22. Average mass loss (%) of corroded rebars.

In the FrGO rebars, the mass loss experienced is highest in comparison to other coated rebars except control/uncoated rebars, indicating again their ineffectiveness without epoxy. The FrGO + GO/CNT coated rebar performs better than PE and has 21% more efficacy in comparison with PE rebars since inner layer of FrGO without epoxy is ineffective and leads to early initiation of corrosion.

results were obtained for the corroded samples extracted from the concrete subjected to 90 days accelerated corrosion at 15 V (Fig. 22b).

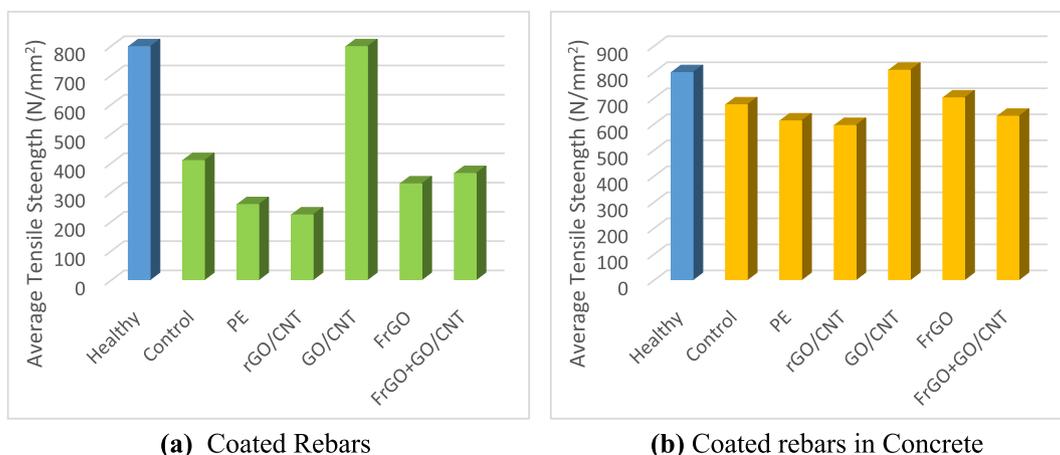
Fig. 23. Average residual tensile strength of the corroded rebars.

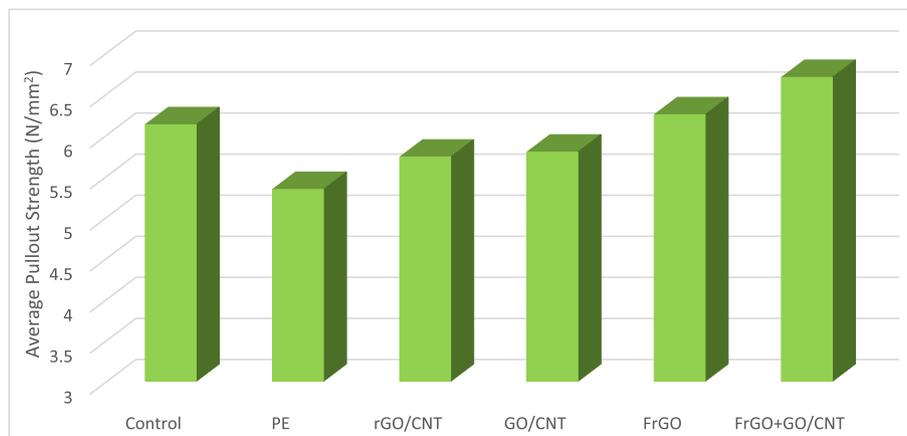
Fig. 24. Average pullout strength of rebars in cylinder.
